Air Permeability and Thermographic Analysis Report

Client:
Project-OECOTOP Building Systems

At:
20A Baskin Cottages
Cloghran,
Co. Dublin.

Date: 11th & 12th August 2007

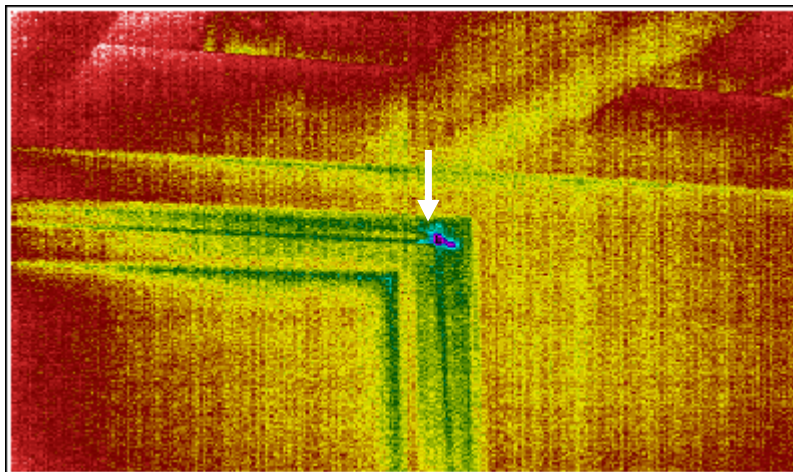
Figure 3 West Window – Infrared (Iron)

Note: In this instance internal temperatures at the time of the survey ranged from 18°C -19°C. Outside temperature = 18°C. Due to the small differentials in temperature the infrared image capture of infiltration was attainable but did not provide for sharp imagery. Arrows indicate the infiltration points.

Figure 4 West Window – Infrared (Rainbow)

Figure 5 West Window – Visible

- 1) Roof space – works ongoing
- 2) Window frames – works ongoing

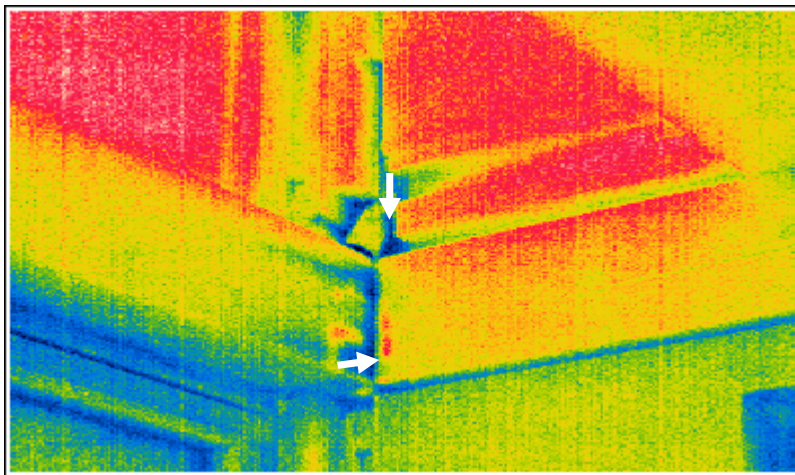
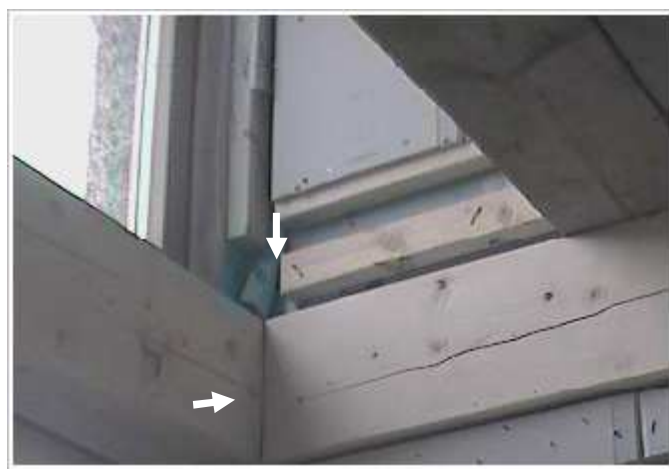
Figure 6 South West Corner Living Area– Infrared (Rainbow)

Figure 7 South West Corner Living Area – Infrared (Feather)

Figure 8 South West Corner Living Area – Visible

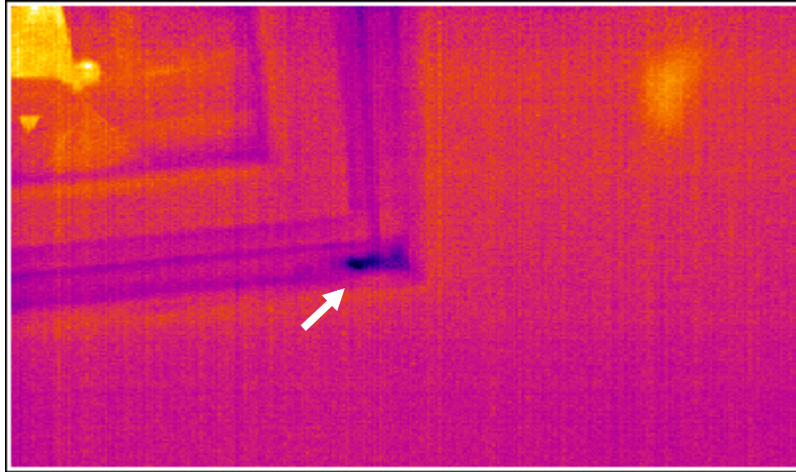
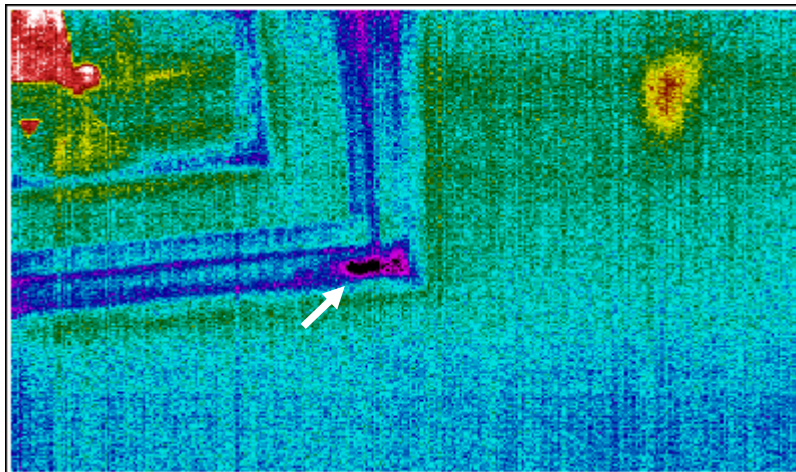
Figure 12 East window right hand side - Infrared (Iron)

Figure 13 East window right hand side - Infrared (Rainbow)

Figure 14 East window right hand side - Visible

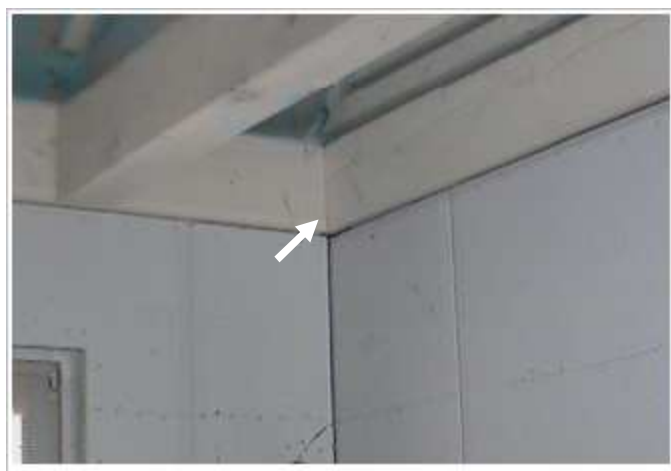
Figure 15 South East Top Corner – Infrared (Iron)

Figure 16 South East Top Corner – Infrared (Feather)

Figure 17 South East Top Corner – Visible

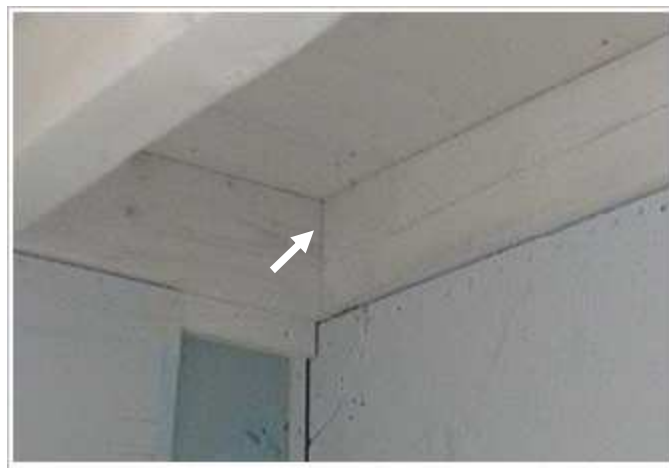
Figure 18 Southwest Top Corner – Infrared (Iron)

Figure 19 Southwest Top Corner – Visible

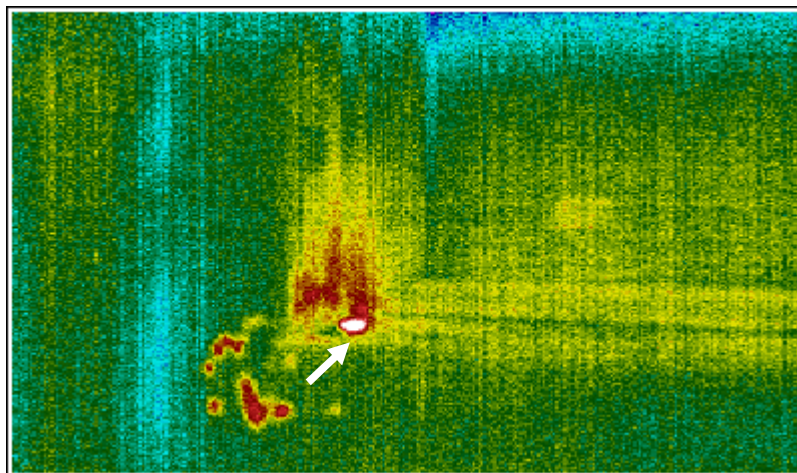
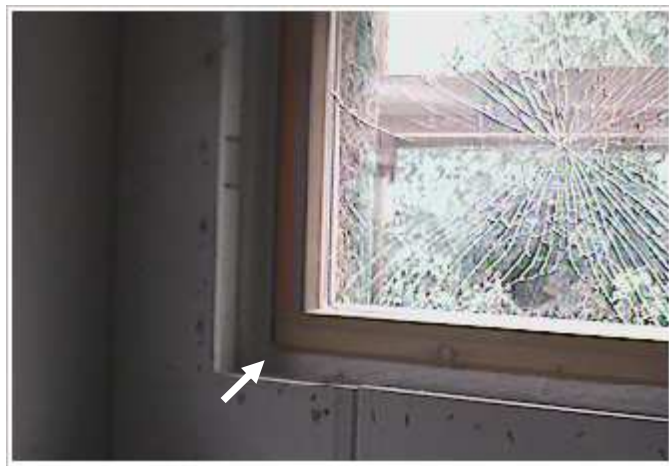
Figure 20 East Windows North Corner – Infrared (Iron)

Figure 21 East Windows North Corner – Infrared (Rainbow)

Figure 22 East Windows North Corner – Visible

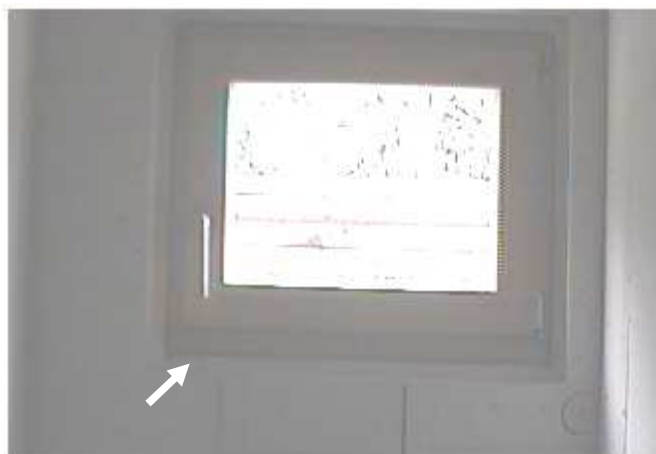
Figure 23 Utility Window – Infrared (Iron)

Figure 24 Utility Window – Infrared (Rainbow)

Figure 25 Utility Window – Visible
